Double Glazed Units with Built-In Venetian Blinds - Failures Can Be Avoided

Robert Knudsen
Danish Technological Institute

The Danish Technological Institute has analysed these units and found different types of failure, all of which could have been avoided during manufacture. Mechanical failure and failures caused by release of chemical solvents were found. This article analyses the failures and proposes methods of avoiding them in the future.

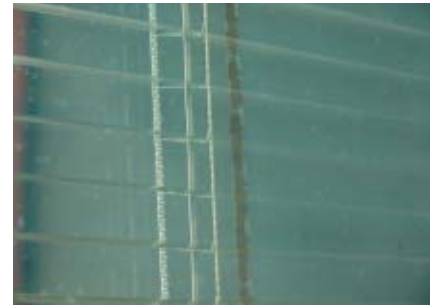
Organic compounds:
The appearance of a whitish contamination on the second glass surface, counted from the outermost glass surface, is the most frequently occurring failure in double glazed units with integral Venetian blinds. Different levels of pollution have been seen, ranging from barely visible to visible from a considerable distance. Figure 1 shows a double glazed unit with a clear whitish coating especially accentuated by the wear track from the ladder string.

The above-mentioned double glazed unit were Venetian blinds with aluminium slats. The whitish contamination could be wiped away with a dry cloth leaving a greasy surface. Chemical analysis showed that the whitish coating consisted of organic compounds and that these compounds could also be found on the surface of the aluminium slats.

Figure 1
Whitish contamination on second glass surface caused by organic solvents

To avoid this whitish contamination all components built in the cavity should be checked for any release of organic compounds. We have 20% of a special order had whitish contamination whereas the rest did not have this type of problem. All the units were produced at the same time and on the same manufacturing line. A fogging test carried out on new units produced on the same manufacturing line following the same system description did not reveal any contamination.

We were unable to find any deviation in the production of the double glazed units or blinds that could have caused failure in approximately 20 % of the

units, whereas the remaining 80 % had no problems. One possible explanation is a variation in the paint used on the slats but we were not requested to investigate this part.

To prevent failure caused by release of organic compounds from the blinds, quality control should ensure that all blinds delivered have stable surfaces.

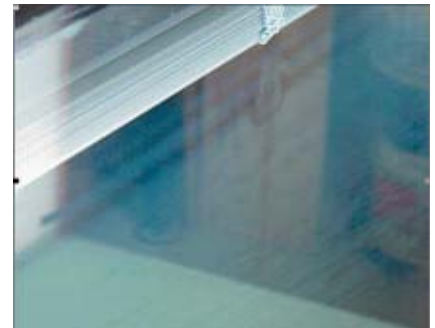
Figure 2
Whitish contamination on the second glass surface caused by corrosion of the surface

In one case it was not possible to wipe away the whitish contamination and it was impossible to remove it with solvents or acid. Chemical analyses showed that the whitish contamination was not of organic compounds but showed that there was a greater concentration of sodium ions than on normal glass surfaces. The contamination is shown in figure 2.

We assume that water has condensed on the second glass surface and that the Venetian blinds have been closed during periods of sunshine whereby the temperature in the cavity increased. High temperature and a thin layer of water results in rapid corrosion of the surface corresponding to what is normally seen in a "punctured" double glazed unit.

To avoid corrosion of the inner glass surface, it is important that the air in the cavity is dried quickly after manufacture, and therefore the holes in the spacer should be designed with the correct size. Especially critical are units filled with atmospheric air containing water vapour combined with a large cavity width.

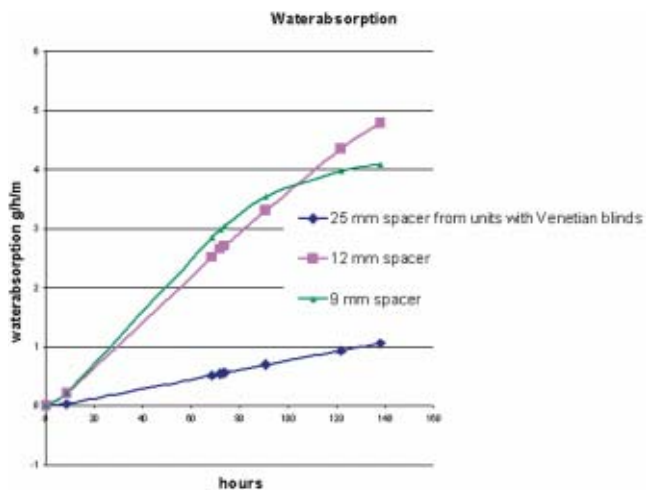
Figure 3.

Water absorption capacity of 3 different types of spacers

be opened. Compared with 9 and 12 mm spacers from traditional double glazed units we measured the capacity of the 25 mm spacer to absorb water from the air.

The spacers were filled with the same type of desiccant and were left freely exposed in laboratory air for 6 days. The results of the weighing of spacers are shown in figure 3. The capacity of the spacer from the unit with the Venetian blind had less than a quarter of the capacity of a normal spacer. The unit with the Venetian blind was produced during the winter and installed a few days after manufacture during a period of cold weather.

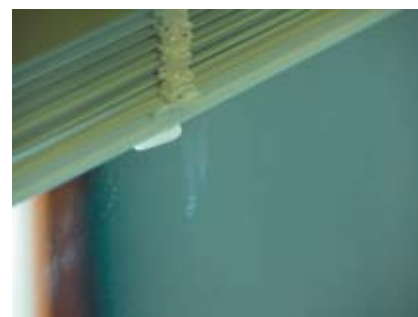
Figure 4.

the glass. Figure 4 shows a unit with marks on the third glass surface counted from the outermost glass pane. The marks are located just below the blind in its rolled-up position in front of each row of ladder string.

The marks could not be wiped away with a soft cloth but could be removed gently with a knife. The glass surface was a soft-coated low-e glass. Chemical analyses showed that the marks were of the same material as the ladder string and not a wear mark in the coating.

Marks on the third glass surface caused by the ladder string

Marks on glass surfaces caused by strings can be avoided with acceptable tolerances between the glass and the blinds and by taking into account possible deflections in the glass caused by climatic changes. In the case of blinds, which can be rolled up with ladder strings, the double glazed units should have greater tolerances to prevent the strings from reaching the glass in a up-rolled position.

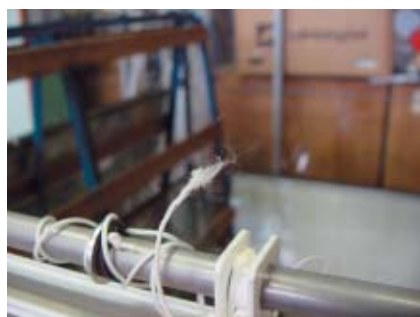
Units have exhibited simple mechanical failures such as broken strings or blinds slowly sliding down when the power supply has been switched off. Figure 5 shows a broken carrying string caused by wear from the sharp edge shown in figure 6. When a carrying string breaks, the blinds will hang lopsided, see figure 7.

Broken carrying string

Broken strings and motor problems can be avoided by removing all sharp edges and by carrying out functional tests (several thousand times) on test units. Automatically controlled blinds should be tested for being rolled up and down 20,000 times plus 20,000 tilt-and-turn operations. Manually controlled blinds should be tested for half this number. During tests the pressure in the cavity should be maintained to correspond to the minimum free distance between glass in winter.

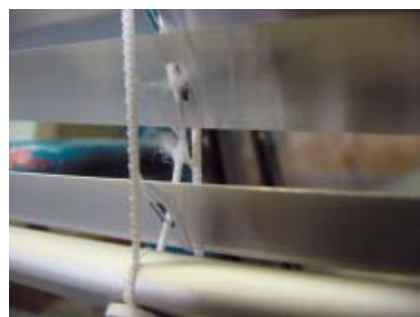
Figure 6

Carrying string with wear marks from sharp edges

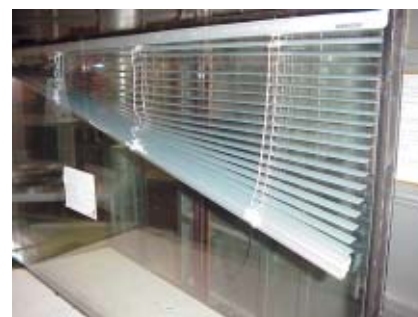
Figure 7

Lopsided Venetian blinds

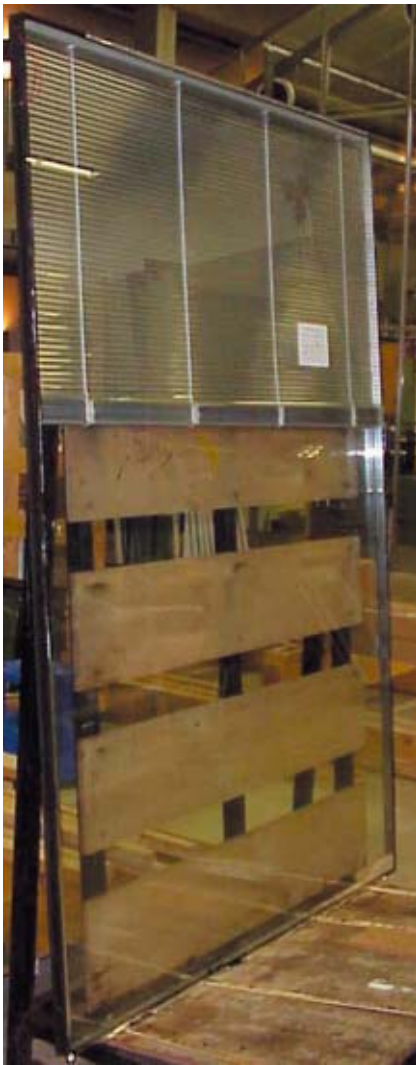
down after switching off the power supply. Measurements of the gear-motor friction showed that the resistance was less than the weight of the slats. This is illustrated in figure 8.

Figure 8
Blinds slowly sliding down after switching of the power supply

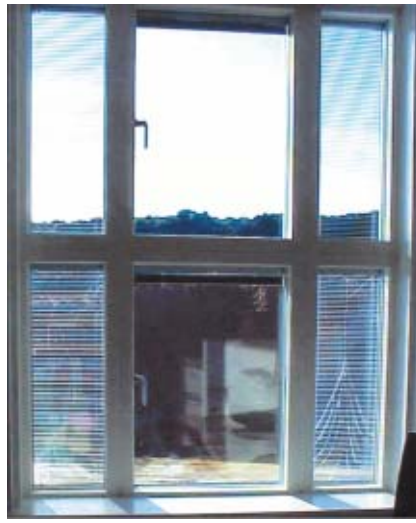
Figure 9
Breakage of inner glass in units with Venetian blinds

The purpose of units with Venetian blinds is to control and reduce the solar energy passing through the unit. This causes higher temperature in the cavity and together with the increased width of the cavity the pressure can increase so much that under some circumstances it can cause the glass to break, see figure 9. A less serious problem is deflection of the glass causing large distortions in reflection from the glass.

Higher temperature together with increased cavity width raises the stresses and deflections in the glass. Often thicker glass is used for the outer glass layer to reduce deflections. For smaller units this can cause breakage of the thin glass.

Glass breakage should be avoided by calculating bending stresses in the glass depending on climatic conditions during manufacture and expected climatic conditions during lifetime. Double glazed units with integral blinds will reach much higher temperature every day compared with normal double glazed units without blinds.
